AFP-3030	"Software Mismatch" Fault	V1.0 CH 29/03/17
AFP-3030	Software Mismatch Fault	V1.0 CH 29/03/17

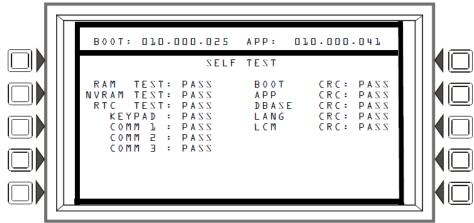
Issue: The panel is displaying the fault "Software Mismatch" following the installation of an additional Loop Card or Loop Control Module (LCM).

The panel checks the firmware revision of any installed Loop Cards when starting up and if the version of the installed firmware does not match that held internally in the panel it will raise a "Software Mismatch".

At the following "Power-up Screen", PRESS and HOLD the < RESET > key located within the FIRE BRIGADE PANEL border, until the entire self-test has completed.
